SSC-366

**THRESHOLD CORROSION  
FATIGUE OF WELDED  
SHIPBUILDING STEELS**

**SHIP STRUCTURE COMMITTEE**

This report presents the development of the near-threshold corrosion fatigue test methodology for welded high strength, low alloy (HSLA) shipbuilding steels. The tests which were developed under this Small Business Innovative Research (SBIR) project will permit the direct evaluation of corrosion fatigue resistance of the weld metal, heat affected zone, and base metal regions. Special filler metals were developed for this project and used to assess the influence of various weld metal constituents on mechanical properties. This report includes descriptions of the preparation and evaluation of the microstructure and mechanical properties for baseline weldments. The development of the partial hydrogen embrittlement method to accelerate the collection of near-threshold corrosion fatigue data is particularly interesting and worthy of further exploration.

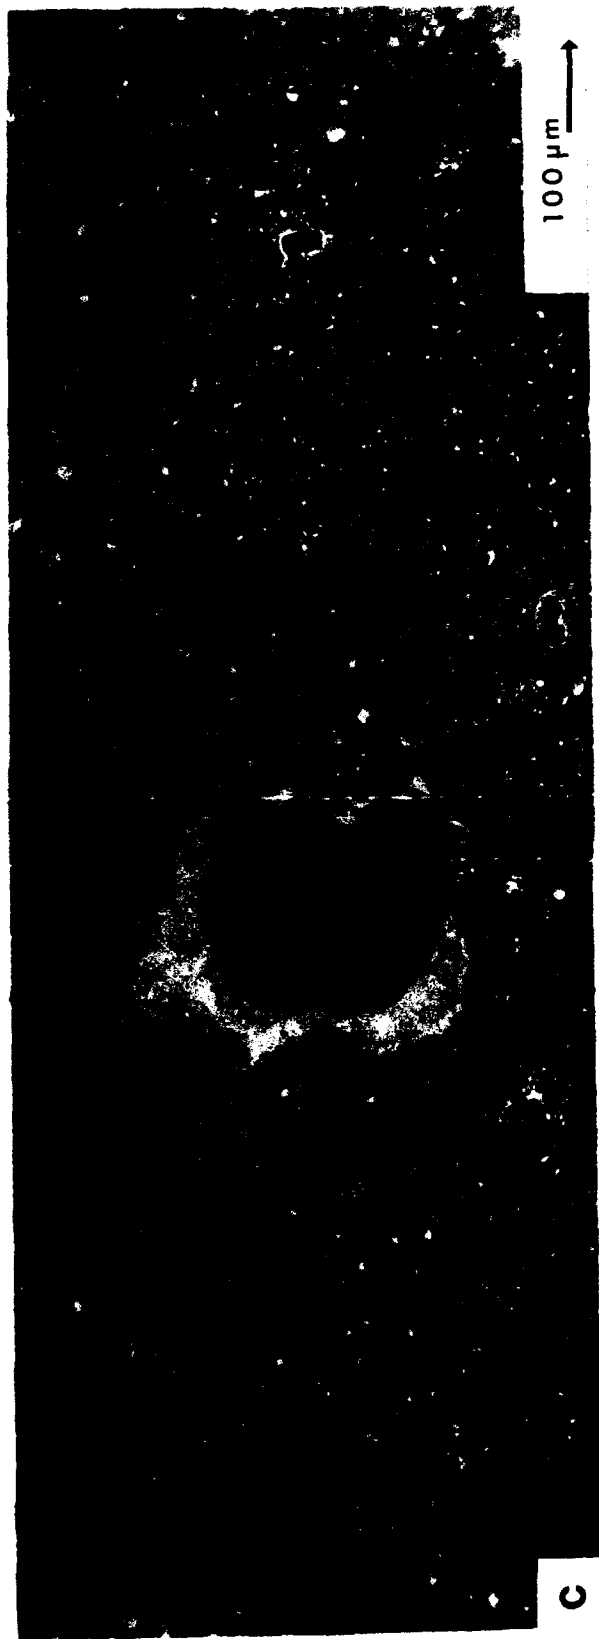
Figure 37. Higher magnification views of MIL S-24645 base metal tested in ASTM seawater at the free corrosion potential at 0.2 Hz under load increasing conditions (test #2).

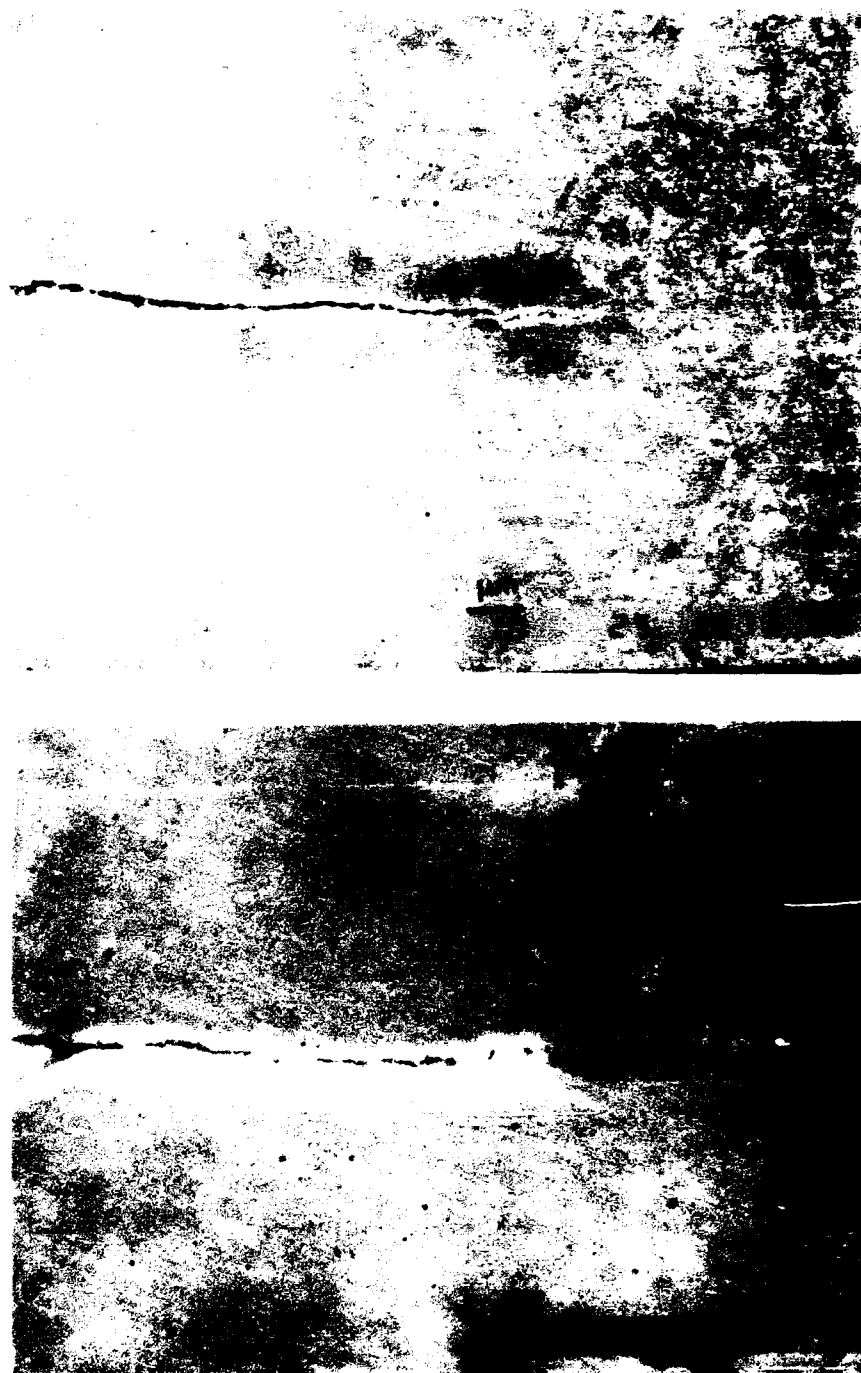
**Figure 53.** SEM micrographs of the fracture path (near crack tip) of MIL S-24645 steel in the weld tested at 10 Hz at -1.0V in seawater: (a) 750 X, 5% Nital; (b) 1500 X, unetched.
